# National Transportation Safety Board

## Marine Accident Brief

### Engine Room Fire on Board Commercial Fishing Vessel *Miss Eva*, with Subsequent Sinking

<b>Accident no.</b>	DCA15LM005
<b>Vessel name</b>	<i>Miss Eva</i>
<b>Accident type</b>	Fire and sinking
<b>Location</b>	Gulf of Mexico, Ship Shoal Block 154, about 35 miles southwest of Grand Isle, Louisiana, 28°40.8' N, 91°12.2' W
<b>Date</b>	December 1, 2014
<b>Time</b>	0708 central standard time (coordinated universal time – 6 hours)
<b>Injuries</b>	Three crewmembers received severe burns, and one crewmember was uninjured
<b>Property damage</b>	Total loss of vessel, estimated at \$550,000
<b>Environmental damage</b>	No sheen was reported from the estimated 3,200 gallons of marine diesel fuel and 100 gallons of hydraulic oil on board
<b>Weather</b>	Clear skies, visibility 6.5 miles,* winds from the east-southeast at 10 knots, seas 1 to 2 feet
<b>Waterway information</b>	Gulf of Mexico, open water

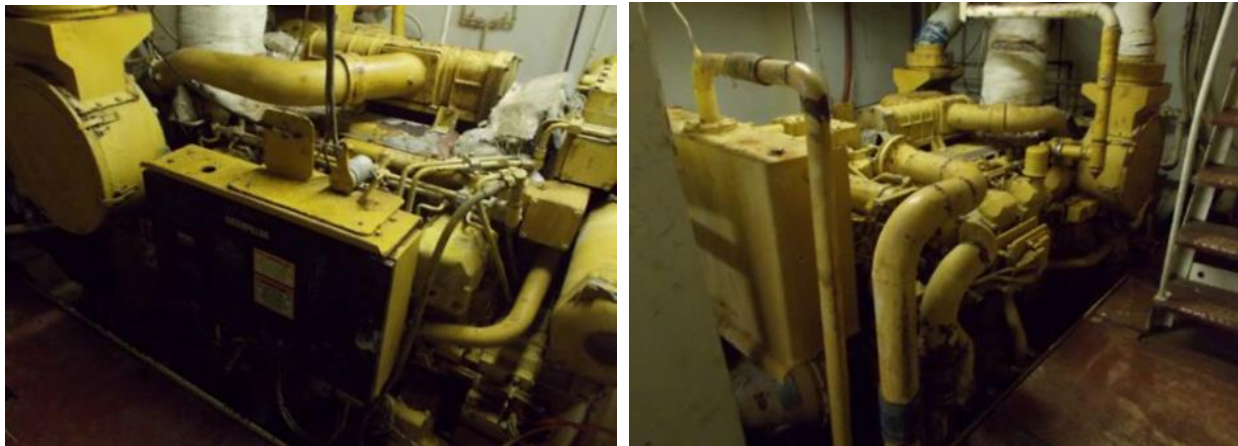
**The *Miss Eva*'s Caterpillar 3508B main propulsion engine. (Photo by K.W. Diers)**

Trident Circle hired a second mechanic to assess the *Miss Eva*'s engine. The mechanic found that the exhaust valve on the no. 6 cylinder of the engine was damaged and that material from the valve had also damaged the fuel injector, piston, connecting rod, camshaft, and portside turbocharger. On October 3, Trident Circle obtained parts from the mechanic's employer, Force Power Systems, a Caterpillar parts and service provider in Houma, Louisiana. The mechanic and his helper performed the repair and engine tests on October 4. They performed this work outside of their normal work hours and outside of their employer's client network.

After the repairs were completed, the *Miss Eva* departed Port Fourchon for another trip. A few days later, the second mechanic received a call from the vessel's operator stating that, while the *Miss Eva* was under way, its main engine high jacket water temperature alarm had activated. The *Miss Eva* returned to port, and, on October 9, the mechanic found that five of the eight head gaskets were leaking due to overheating. The mechanic stated that the engine was "making air," a term used to describe when combustion exhaust is leaking into the cooling system and/or coolant is being pulled into the cylinder on the intake stroke.

The operator instructed the mechanic to reseal seven of the eight cylinder head gaskets (the no. 6 cylinder head gasket was replaced during the October 4 repair). The mechanic and his helper resealed the seven cylinder head gaskets and refilled the jacket water system with potable water instead of a diesel engine antifreeze/coolant mixture. According to the mechanic, as with the previous repair on October 4, no such mixture was available on board the vessel when the mechanic refilled the jacket water system. Additionally, the mechanic replaced all of the fuel lines due to corrosion. The mechanic told investigators that he advised the owner and the operator to have the vessel return to port for the engine manufacturer's recommended 250-hour check, during which the exhaust valves on the engine cylinders could be readjusted and the fuel injectors could be reset. The owner and the operator stated that they were not made aware of the recommendation.

On October 11, the *Miss Eva* departed Port Fourchon to continue fishing operations. The vessel returned to its homeport in Texas about 4 days later to offload the catch. On November 2, the *Miss Eva* departed for the trip during which the accident occurred. While under way, the vessel's main engine began to experience higher-than-normal fuel consumption. On November 20, the operator contacted, via text message, the mechanic who had most recently performed repairs to the *Miss Eva*. The operator relayed information from the master indicating that the main engine was consuming 35 gallons of diesel fuel per hour, a 15-gallon increase from the normal consumption rate. Before this time, the vessel's engine had accumulated more than 250 hours since its latest repair, but the recommended check for that interval had not been performed.

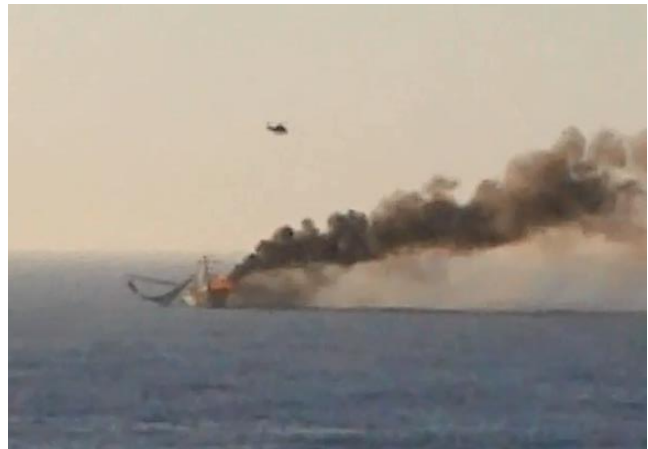
The left photo shows the *Miss Eva*'s liferaft located above the wheelhouse. (Photo by K.W. Diers)  
The right photo shows the *Miss Eva* on fire with an Era helicopter circling the liferaft and the vessel. (Image from video by Chad Guidroz)

The *Miss Eva* remained afloat and burning. A sister vessel, the commercial fishing vessel *Nikolas*, arrived on scene to attempt to salvage the *Miss Eva*'s cargo. The *Nikolas*' master noticed that the *Miss Eva*'s bulwarks and hull plating were pushed outward, which he believed were signs of an explosion. About 4 to 6 hours after the fire started, the *Miss Eva* sank bow first in water about 60 feet deep near Ship Shoal Block 154. The *Miss Eva* was not salvaged.

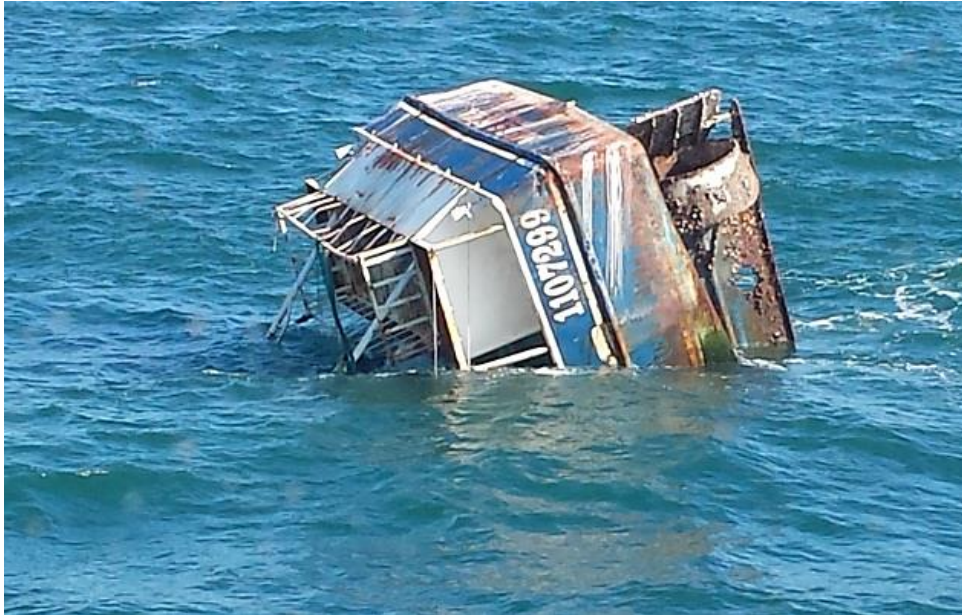
The *Miss Eva* sinking bow first. (Photo provided by master of sister vessel the *Nikolas*)
